## Funk Inspection Services, Inc.

**Date:** May 2026

**Reference:** 100 So.. 10<sup>th</sup> Ave. Longport, NJ

# Inspection Summary

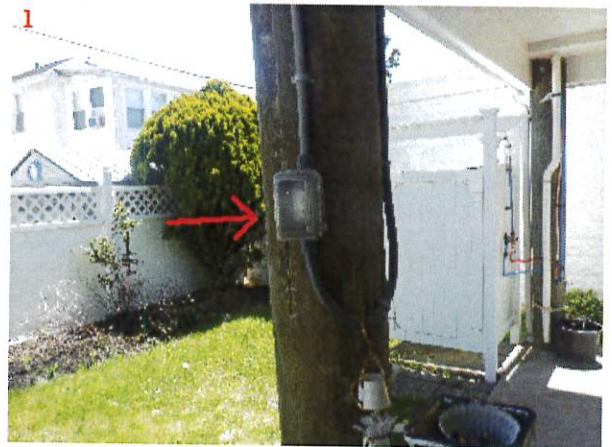
#### Outside Outlets

Rear area receptacle is not GFCI protected, GFCI recommended.

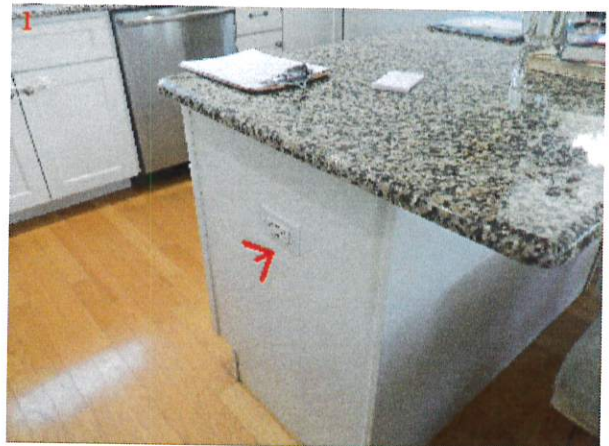
#### Kitchen Wall Receptacles

Care should be taken while using the kitchen island receptacles, hanging cords could present a hazard.

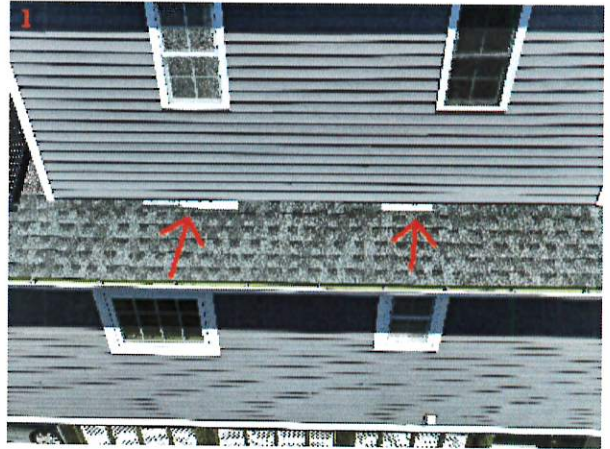
A couple of show shingles are missing on the lower south side roof, appropriate repairs are needed by a qualified roofing contractor.

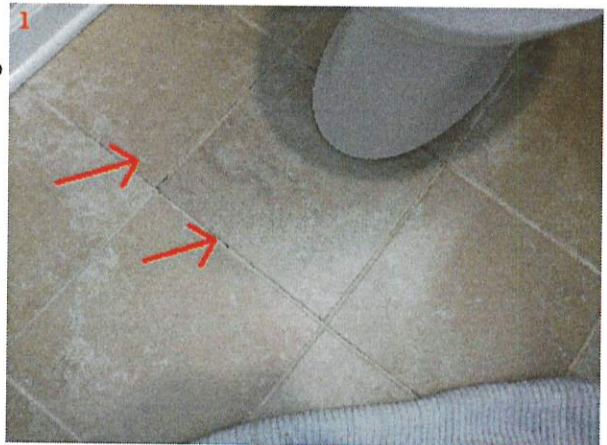
Loose floor tiles noted at the base of the toilet, evaluate and repair/replace as needed.

As with all of our recommendations, consult with a contractor, prior to settlement, in order for them to determine cost of repair & extent of damage.

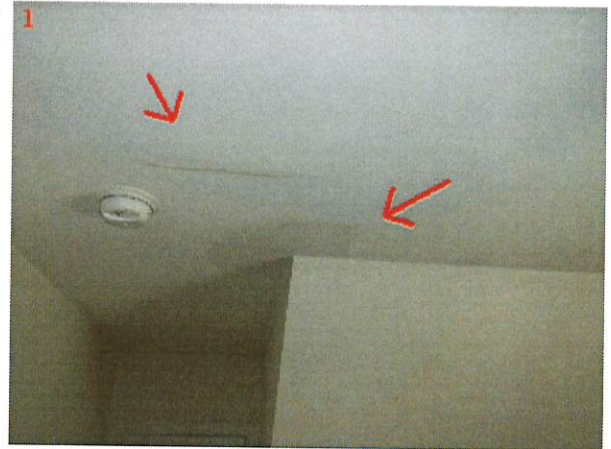
#### Interior Ceilings

Past signs of potential water penetration and cracks noted. 2nd floor rear bedroom ceiling north side. The area was dry at the time of the inspection. Signs of past repairs to ceiling noted. Obtain history of repairs from seller.

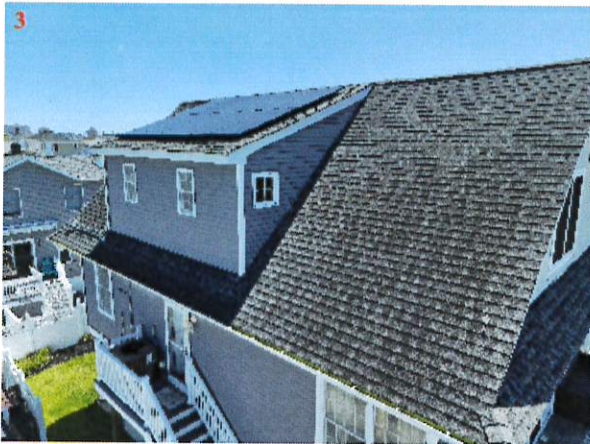
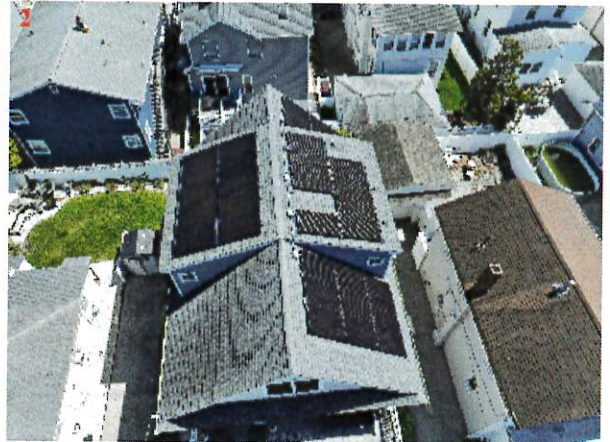
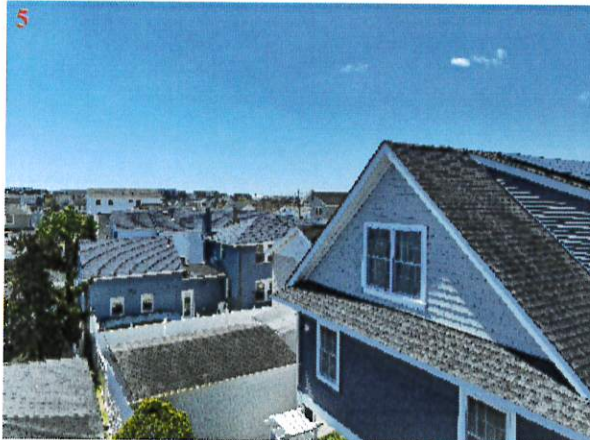
Other = drone  
Observations limited by drone may not fully reveal the condition of the roof surface materials.  
Obtain roof warranty from the general contractor and roof installation contractor.

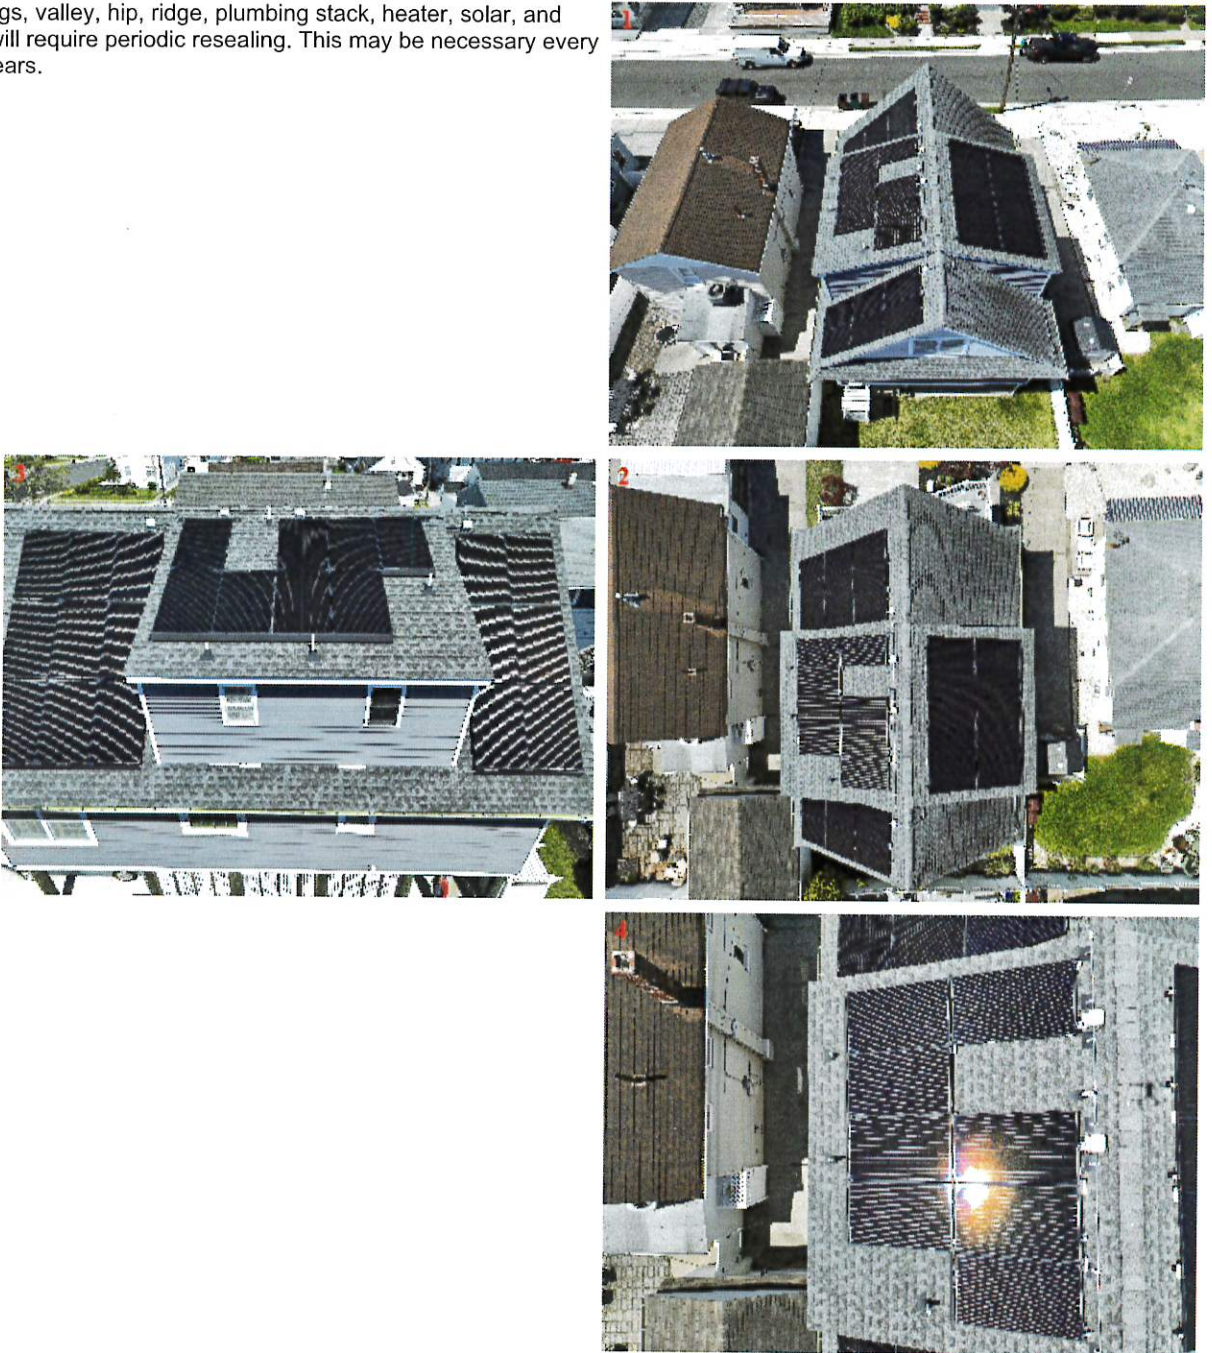
All flashings, valley, hip, ridge, plumbing stack, heater, solar, and sidewall will require periodic resealing. This may be necessary every several years.

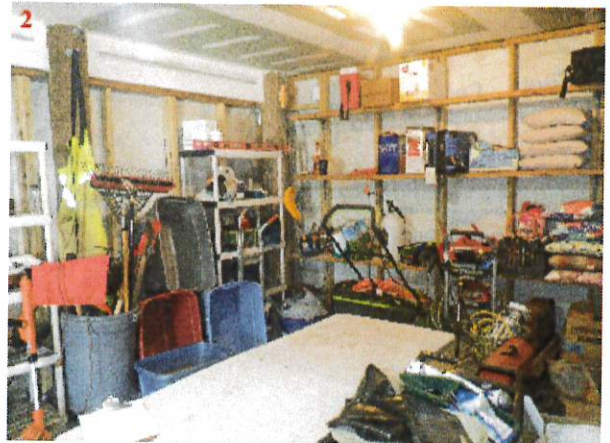
Overall condition of the carport, acceptable  
Storage limited observations.

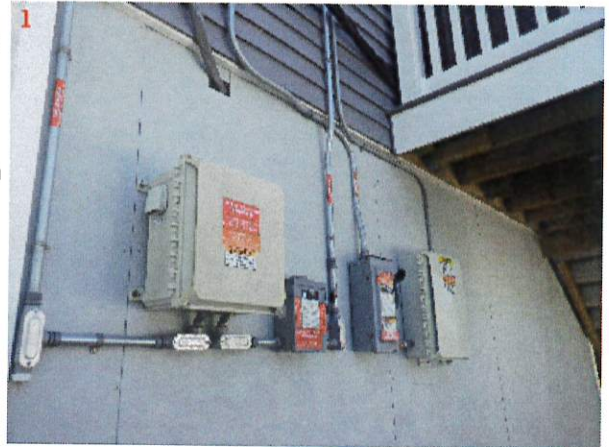
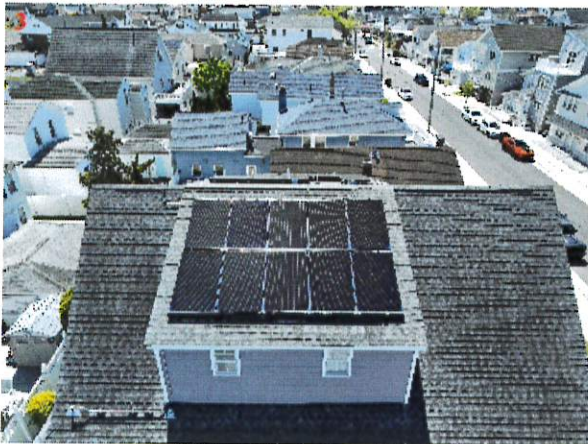
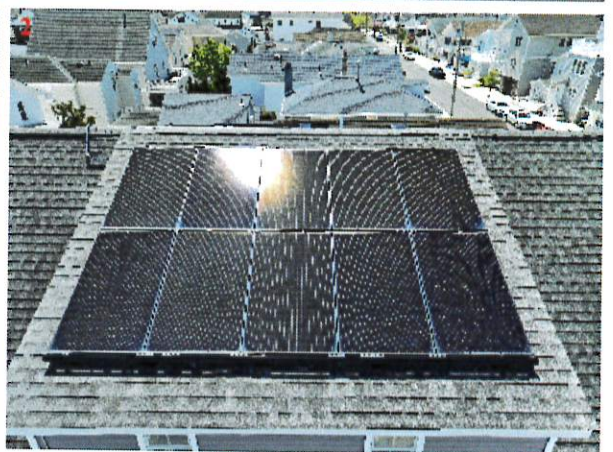
The building is currently serviced by a 200 amp service. The main panel is located in the 1st floor bedroom. The main panel disconnect is located in the main panel. The panel cover was removed and the wires/breakers/panel inspected. There overall condition was satisfactory.

Circuit breakers are mechanical devices. They should be turned off/on on an annual basis in order to exercise these devices. Solar system and all related equipment not inspected and not a part of this inspection.

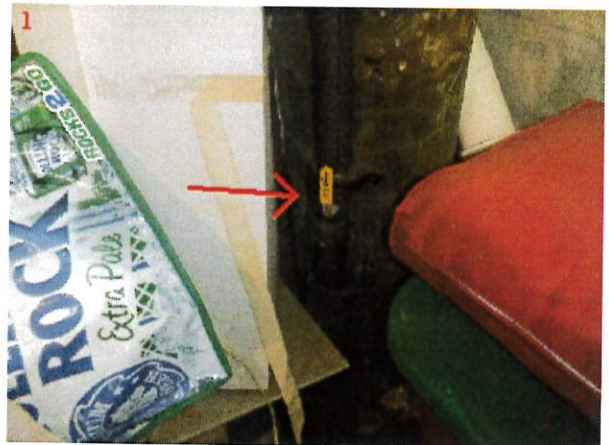
Monitor all water shutoffs for signs of leaks, this appears to be the house main water shutoff.

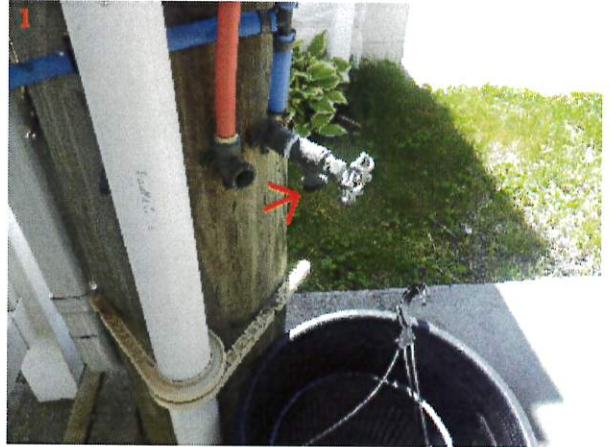
### Type of Outside Spigots

Unprotected hose connections should be shut off and drained before first freeze each year.  
A small drip noted at the rear exterior shower drain shutoff, evaluate and repair as needed.

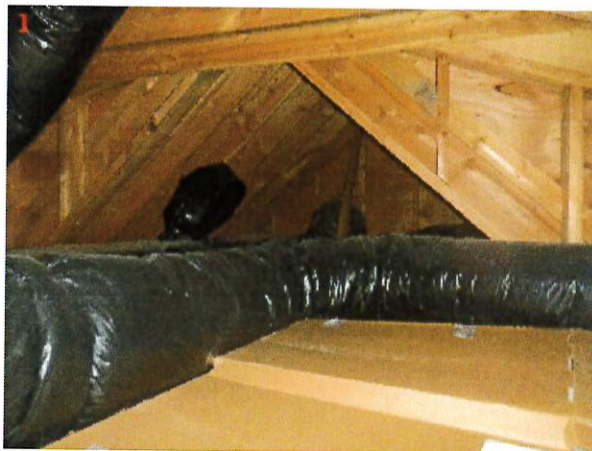
#### ATTIC

Overall condition of attic area - acceptable.  
Access limited to floored areas only, limited observations due to HVAC ducting and equipment.

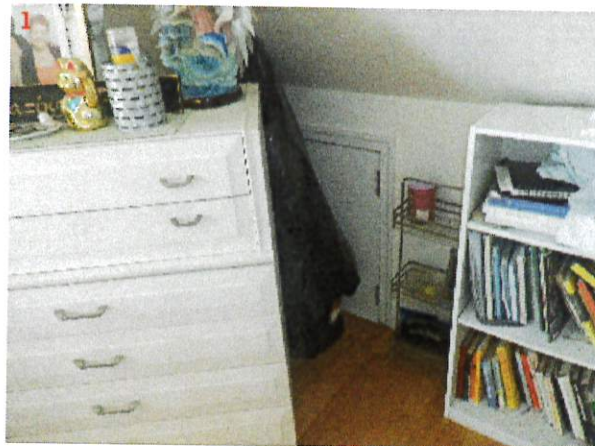
#### Attic Entry Access

Other = sidewall bedroom access panels  
Limited observations due to storage within the side wall areas and storage in front of access panels.
